The control for the Hijend hotel was originally designed as a full DDC system. But it, along with the central plant was heavily value engineered during the bidding cycle due to budget issues. During the control system value engineering process:

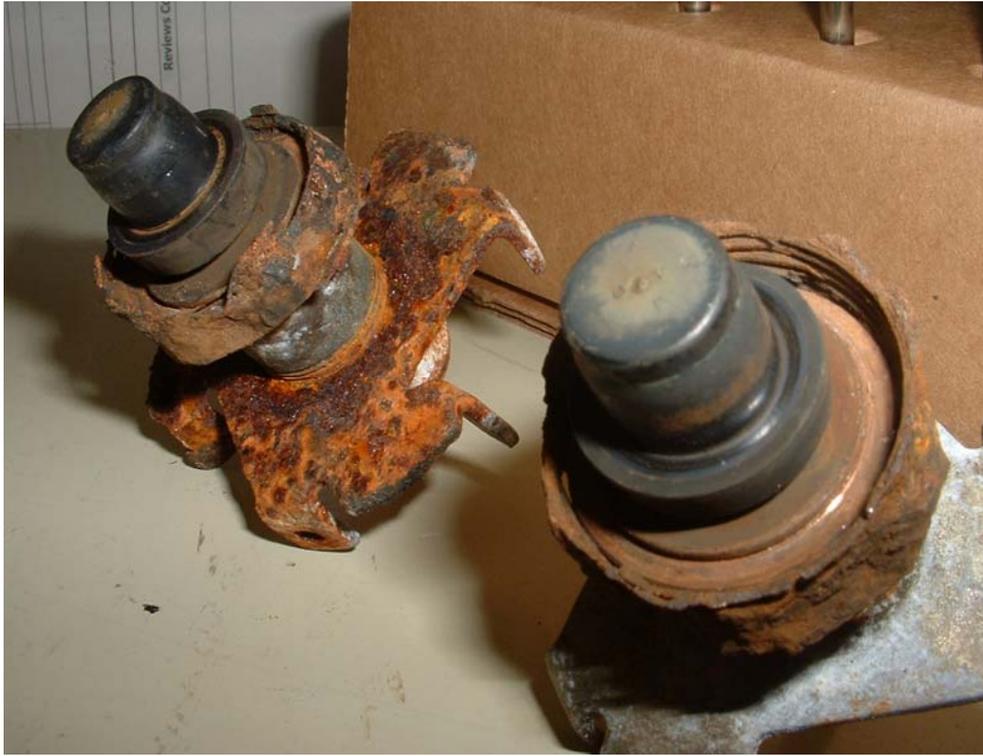
- a. Guest complaints due to the "click" that occurs when the EP switches are triggered.
 - b. A poor insulation detail for the original fan coil unit chilled water valves results in significant corrosion of the valve bonnet. As a result, when the corrosion is severe enough, when full main air pressure is applied to close the valve, the bonnet fails and the guest room floods. The resulting water damage to the room as well as adjacent rooms (both next door and below) is expensive, especially when the funds paid to compensate the guests are taken into account.
