The control for the Hijend hotel was originally designed as a full DDC system. But it, along with the central plant was heavily value engineered during the bidding cycle due to budget issues. During the control system value engineering process:

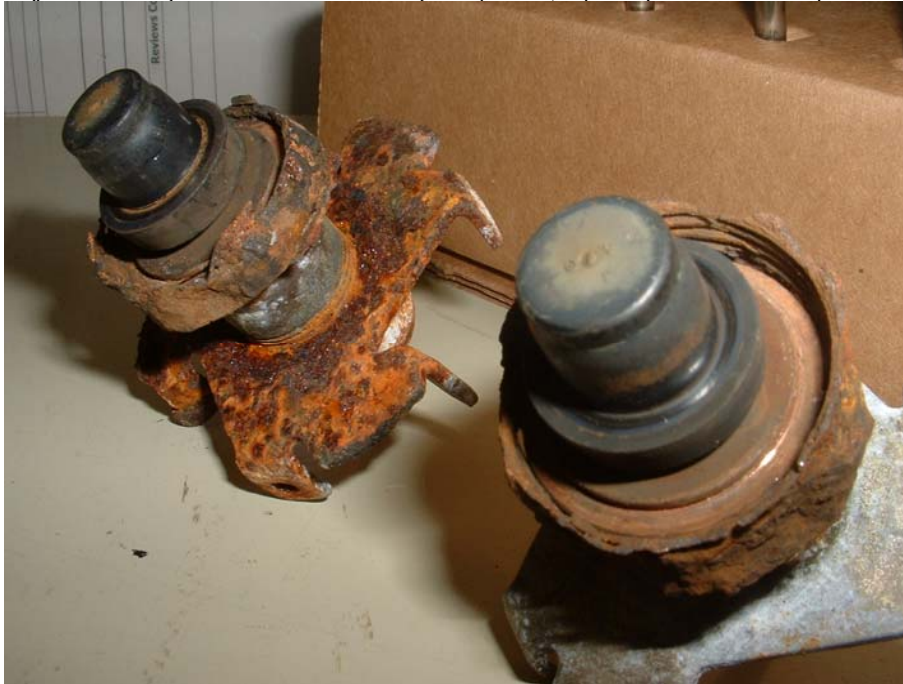
- c. A poor insulation detail for the original fan coil unit chilled water valves results in significant corrosion of the valve bonnet. As a result, when the corrosion is severe enough, when full main air pressure is applied to close the valve, the bonnet fails and the guest room floods. The resulting water damage to the room as well as adjacent rooms (both next door and below) is expensive, especially when the funds paid to compensate the guests are taken into account.

The operating team is aware of issues "a", "c", and "e" but not the other issues. And they do not fully appreciate the energy cost implications of the issues. But as a result of what they do know, they are converting fan coils to electric valves when issue "c" occurs or if they have a guest room out of service for some reason and have enough time to make the change. At this point, about 5% of the rooms have been upgraded. They have put in for a CapEx project to convert to electric valves on a floor by floor basis but it keeps getting put off because of the cost and lost revenue associated with taking guest rooms out of service.

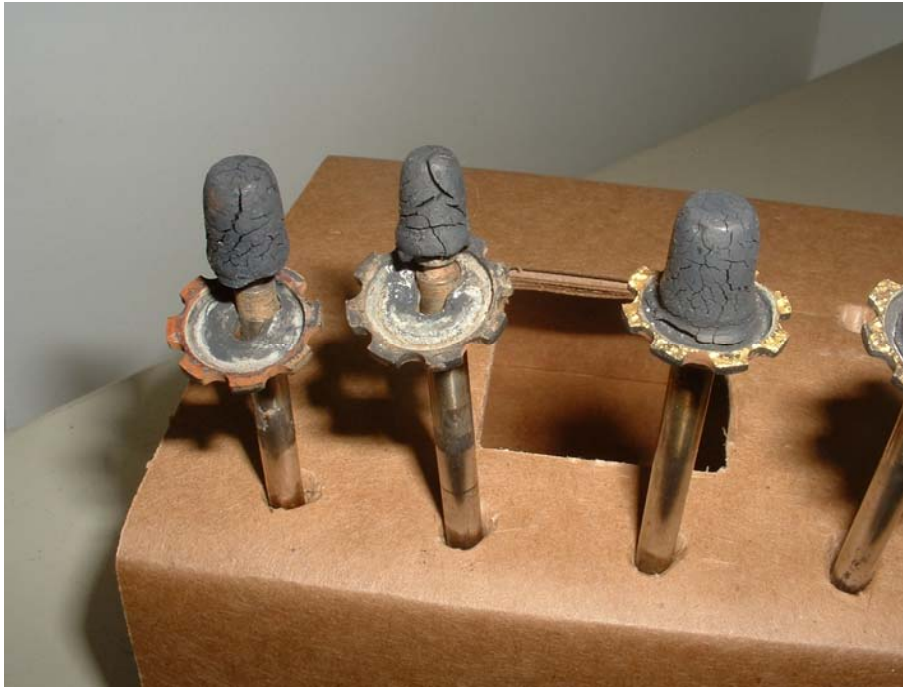
- d. The valve plugs on the original hot water valves were rubber, which over the years has cracked and eroded away, resulting in significant leak-by when the valve is closed. In addition to compromising the cooling capability of the fan coil unit, the leak-by imposes a simultaneous heating and cooling load on the central plant.
